**JCAA/JG-PP No-Lead Solder Project:
-55°C to +125°C Thermal Cycle Testing Final Report**

Rockwell Collins Advanced Manufacturing Technology Group

**Contract: GST 0504BM3419
Subcontract: BM3419-02**

**May 28, 2006
Revision B**

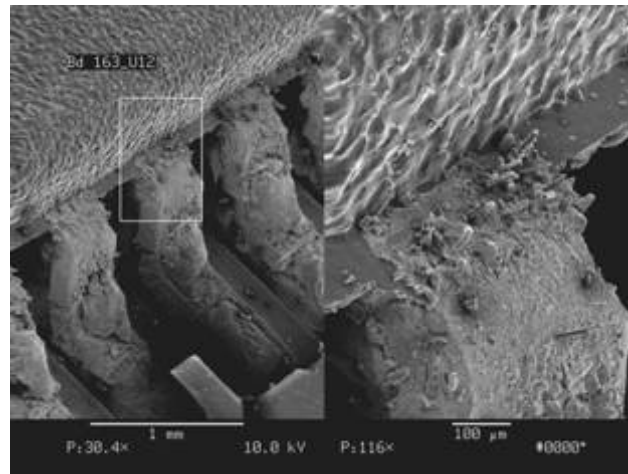
Figure 20 thru Figure 24 illustrates typical tin whiskers found on the TSOP-50 components with SnCu surface finish. This TSOP-50 component was from the legacy (“Rework”) test vehicle. It was originally reflow soldered with a SnPb solder alloy and then manually reworked with a SAC solder alloy as part of the overall rework impact segment of the investigation test matrix (Figure 2). Tin whiskers were found on lead surfaces that were not soldered (the upper knees of the component leads and lead faces) and would be characterized as dense fields with a “worm-like” appearance. SEM EDX analysis was used to confirm that the whiskers were comprised of tin (Figure 25: note gold (Au) presence due to SEM preparation procedure).

Figure 20 SEM image of TSOP component with SnCu surface finish showing tin whiskers on upper knee of lead

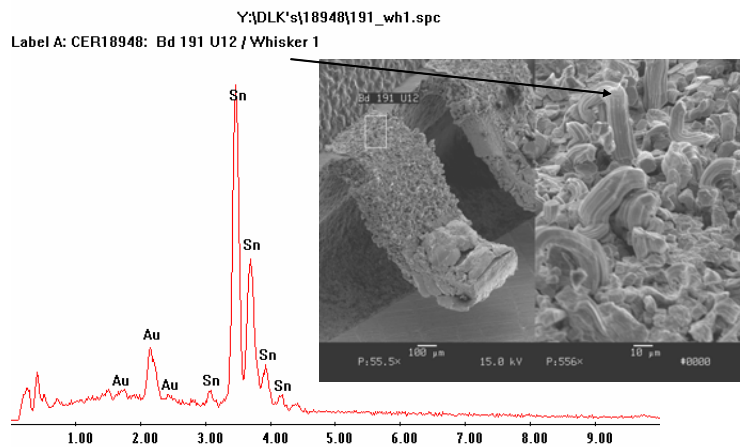
Figure 25 SEM EDX scan of a single tin whisker, TSOP-50 with SnCu surface finish, showing chemical composition.

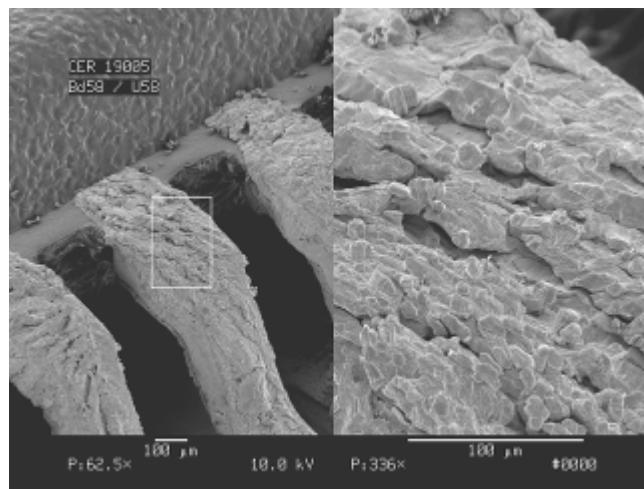
Only a handful of whiskers were observed on the TQFP-144 components for all of the test vehicles. However, the whiskers observed were of significant interest. Figure 26 thru Figure 28 illustrate a TQFP-144 component, with a matte tin surface finish, on a legacy (“Rework”) test vehicle that was soldered with SnPb solder. Small lead (Pb) whiskers were found on the upper knee of the component lead. The Pb whisker phenomena were also observed sporadically on the TSOP-50 components with SnPb surface finish (Figure 29 thru Figure 31). The Pb whiskers observed in this investigation were significantly larger than whiskers found on SnPb finishes documented in other industry investigations [9].

Figure 26 SEM image of whiskers, TQFP component with matte tin surface finish

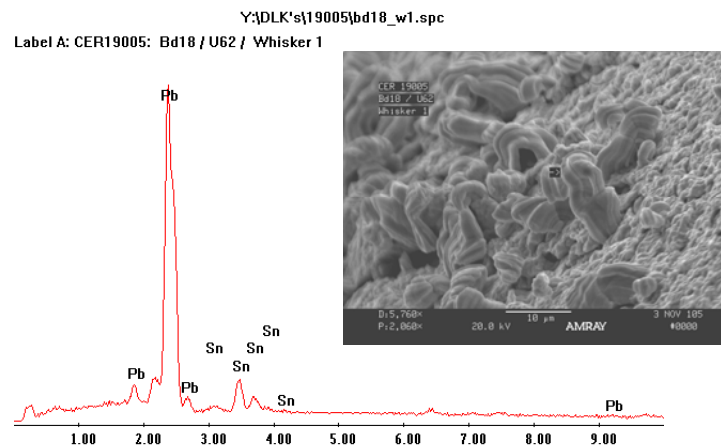
Figure 31 SEM EDX scan of an individual whisker, TSOP component with SnPb surface finish showing Pb chemical composition

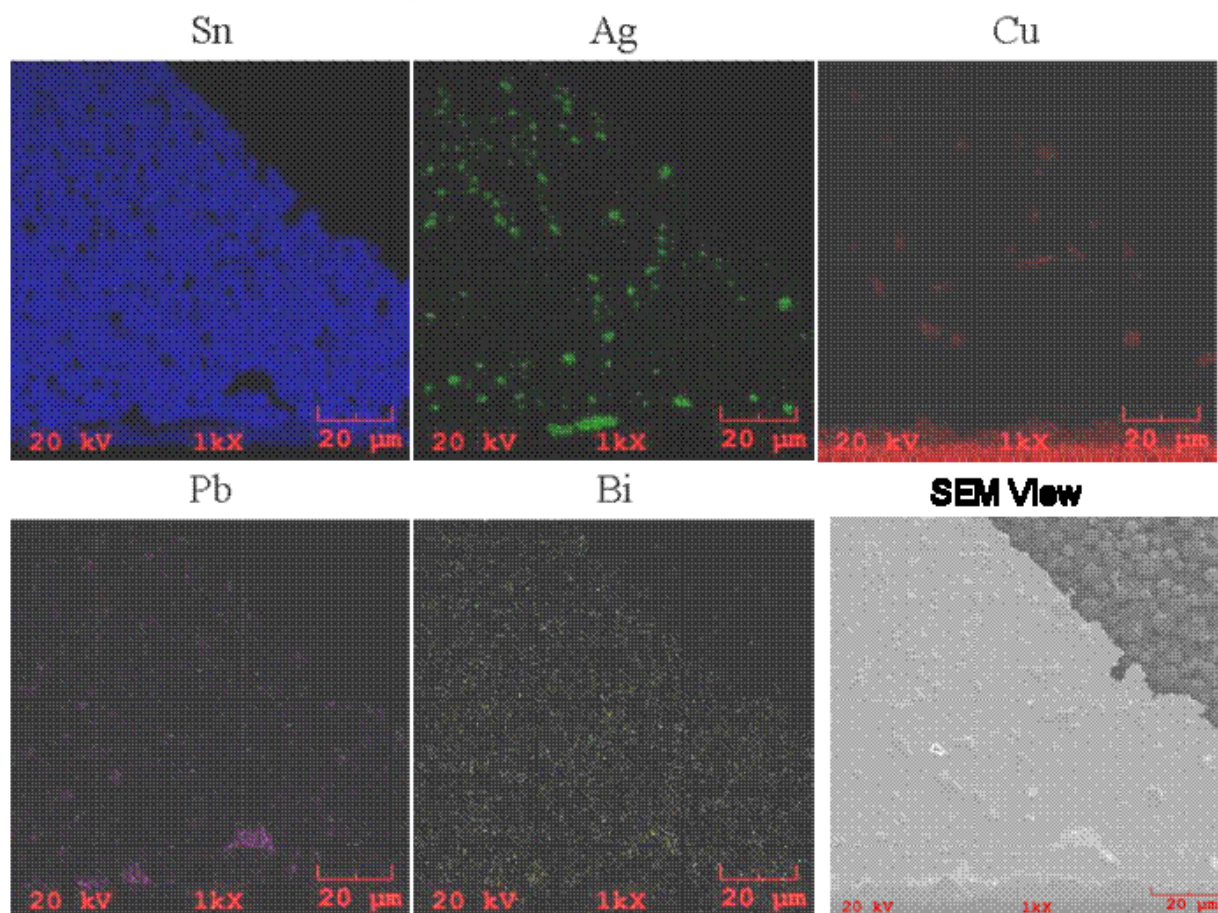
Optical microscopy and scanning electron microscopy (SEM) inspection of a sample of the failed TSOP-50 SACB-SnPb solder joint combination was conducted. No evidence of a SnBiPb microstructural phase was observed. SEM elemental mapping was conducted on a sample of the failed TSOP-50 SACB-SnPb solder joints. Figure 33 illustrates the typical results for the mapping. No segregated SnBiPb microstructural phase regions were found. Some small segregated regions of Pb were observed in the solder joints.

Figure 33 SEM elemental mapping results for SACB-SnPb solder joint after 4743 thermal cycles

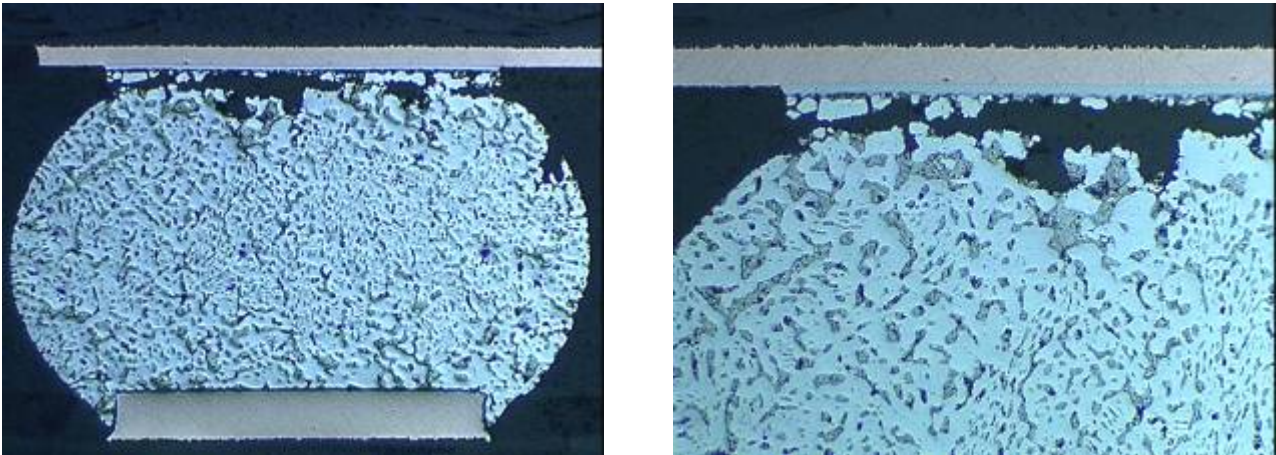
Figure 35 (left) BGA-225 SnPb-SnPb solder joint; (right) magnified view of solder joint crack path (test vehicle 58)

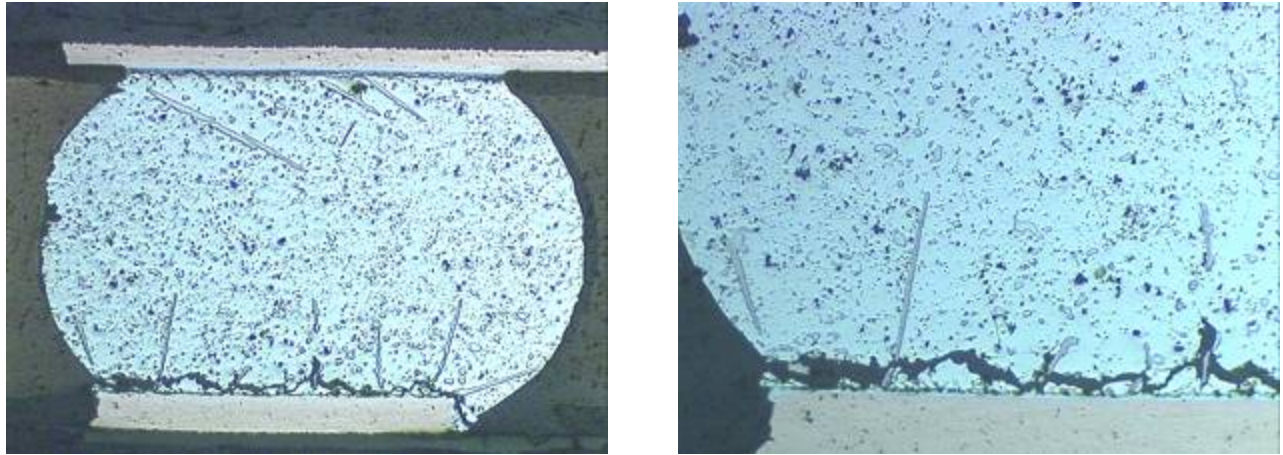
Figure 36 shows a BGA-225 SAC-SAC combination which is typical of a matched SAC solder combination. This solder joint had a uniform original microstructure and failed after completing 3011 total thermal cycles.

Figure 36 (left) BGA-225 SAC-SAC solder joint; (right) magnified view of solder joint crack path (test vehicle 86)

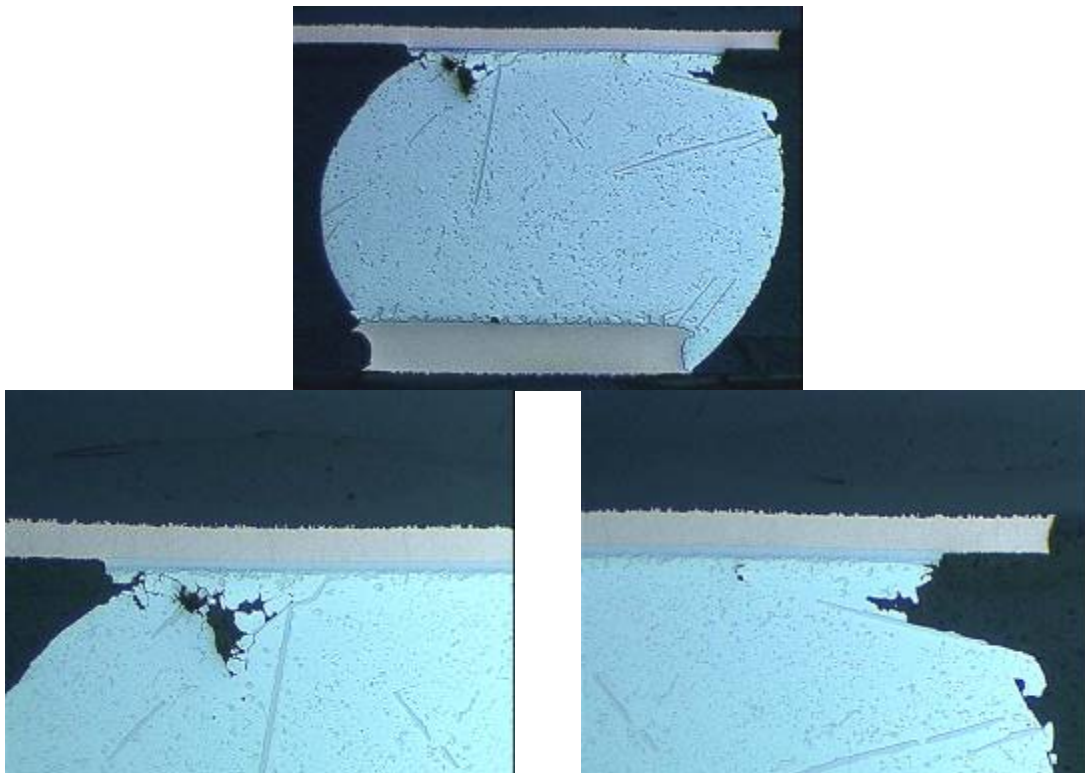
Figure 37 illustrates that the non-eutectic solidification behavior of the SAC solder alloy can produce some non-uniform solder joint shapes that have good thermal cycle reliability – the solder joint had not failed after 4743 total thermal cycles.

Figure 37 (top) BGA-225 SAC-SAC solder joint; (left, right) magnified view of solder joint (test vehicle 85)

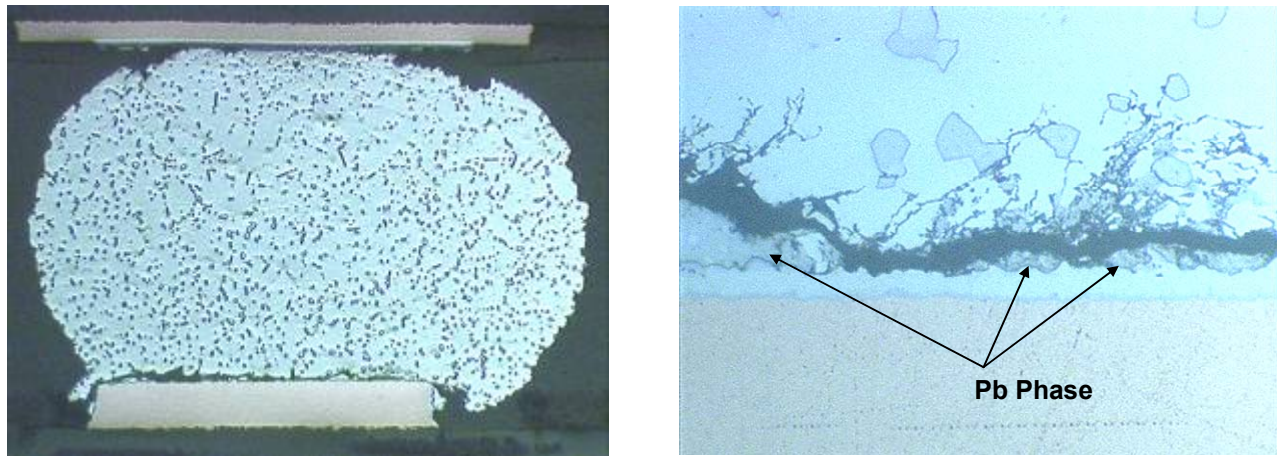
The legacy (“Rework”) test vehicles did contain a number of rework BGA-225 component combinations that demonstrate that a non-uniform solder joint microstructure will result in degraded solder joint thermal cycle integrity. Figure 38 shows a BGA-225 SnPb-SnPb combination that was reworked with a BGA-225 SAC component. This solder joint had a non-uniform original microstructure and failed after completing 822 total thermal cycles. Examination of the solder joint crack path revealed that some of the original SnPb remained on the test vehicle pad after the original BGA-225 SnPb component was removed despite extensive rework procedures to avoid any Pb contamination.

Figure 38 (left) BGA-225 SAC-SAC solder joint; (right) magnified view of crack with Pb phase present

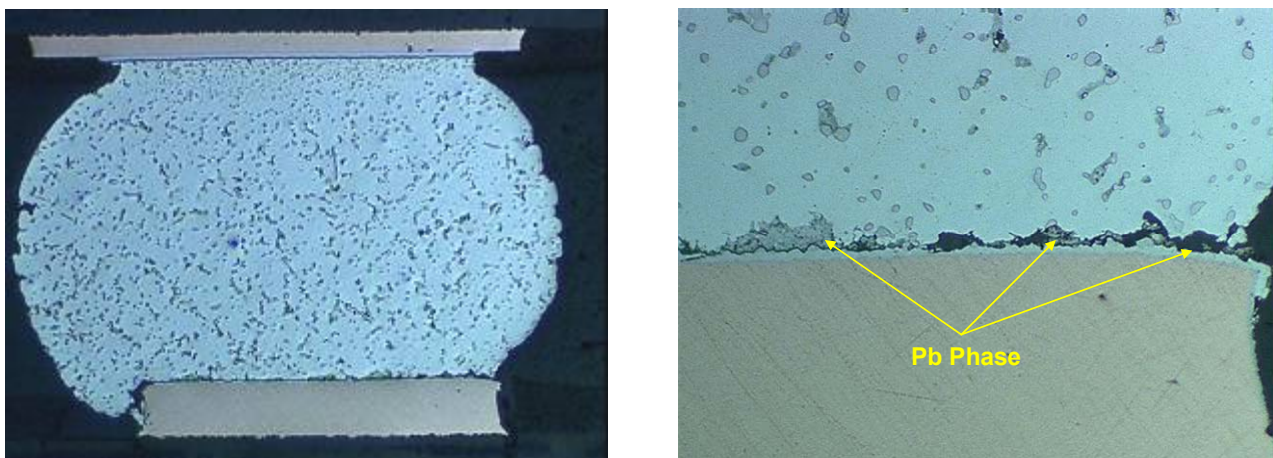
Figure 39 (left) BGA-225 SAC-SAC solder joint; (right) magnified view of crack with Pb phase present

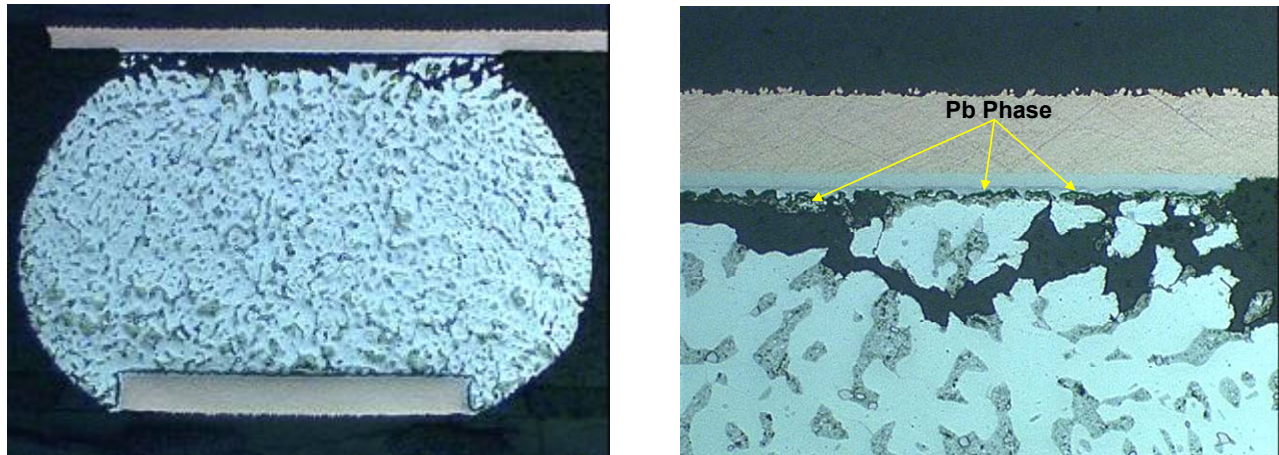
The Pb contamination of a BGA-225 SAC solder joints was also found during the failure analysis of several test vehicles in which SAC solderpaste was used with a BGA-225 SnPb finish. A review of the test vehicle assembly reflow profiles shows that the achieved reflow temperatures should have resulted in the SnPb solderball undergoing complete dissolution. However, the metallographic cross-sections show that some Pb phase present in the crack paths, causing solder joint degradation (Figure 40 and Figure 41: test vehicle 88). The authors believe that Pb contamination is a case of metallurgical incompatibility that can be minimized but not eliminated through enhanced process control. High performance applications may determine that the risk associated with this phenomenon is too high for their products.

Figure 40 (left) BGA-225 SAC-SnPb combination solder joint; (right) magnified view of crack with Pb phase present

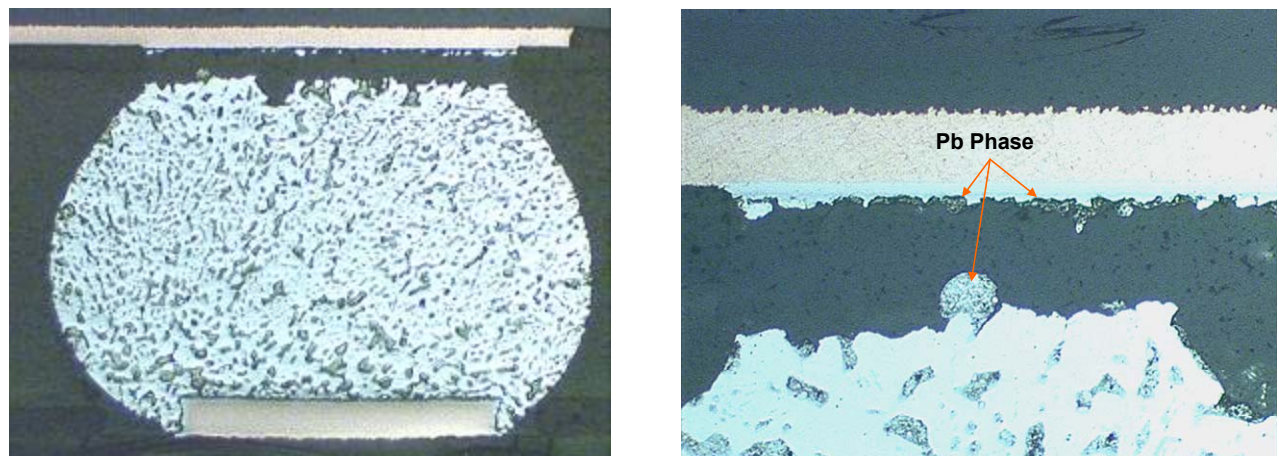
Figure 41 (left) BGA-225 SAC-SnPb combination solder joint; (right) magnified view of crack with Pb phase present

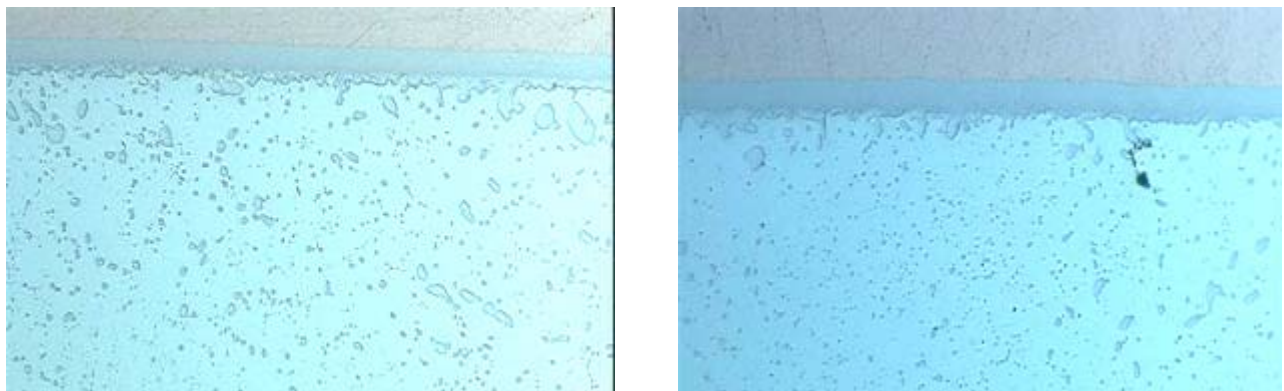
The thermal cycle testing was halted after 4743 thermal cycles. The amount of accumulated solder joint aging time at 125°C for this number of cycles, based on the 30 minute dwell time, was approximately 2372 hours. Failure analysis was conducted on a number of BGA-225 components to determine if Kirkendall voiding was present. Additional metallographic cross-sectioning precautions were followed to avoid smearing over possible voids or to artificially introduce voids. The cross-sections were examined in both etched and unetched conditions. Figure 43 shows the typical solder joint/intermetallic interface observed after 2372 hours. No Kirkendall voiding phenomena was observed during the optical examination of the cross-sections. SEM examination of a number of samples was conducted to determine if Kirkendall voiding was present. Figure 44 shows the typical solder joint/intermetallic interface observed during the SEM examination after 2372 hours. No Kirkendall voiding phenomena was observed. The BGA-225 solder joint/intermetallic interfaces produced in this study are more representative of real world electronic product thermal excursions than the high temperature static baking conditioning that has produced a number of the Kirkendall voiding reports. If a SAC solder alloy is more prone to Kirkendall void formation, the more relevant concern would be “what is the time duration in real world thermal excursion terms that produces Kirkendall voiding solder joint integrity risk?”. The authors believe that the results of this investigation show that some of the industry Kirkendall voiding phenomena concerns may be overstated.

Figure 43 (left/right) BGA-225 SAC-SAC combination cross-section of solder joint/intermetallic interface

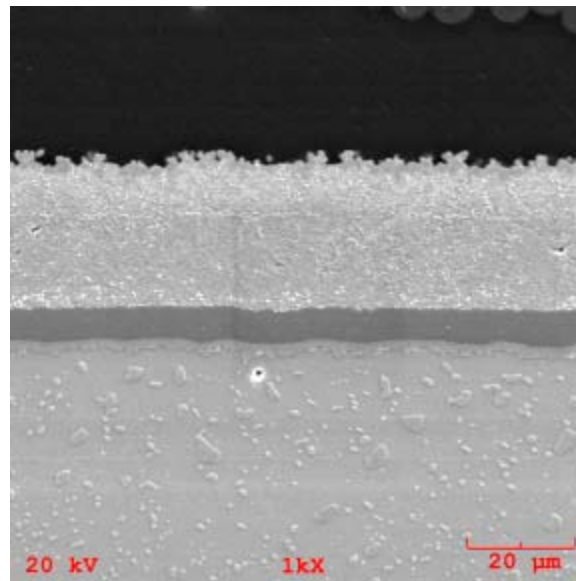
Figure 44 BGA-225 SAC-SnPb combination SEM view of solder joint/intermetallic interface

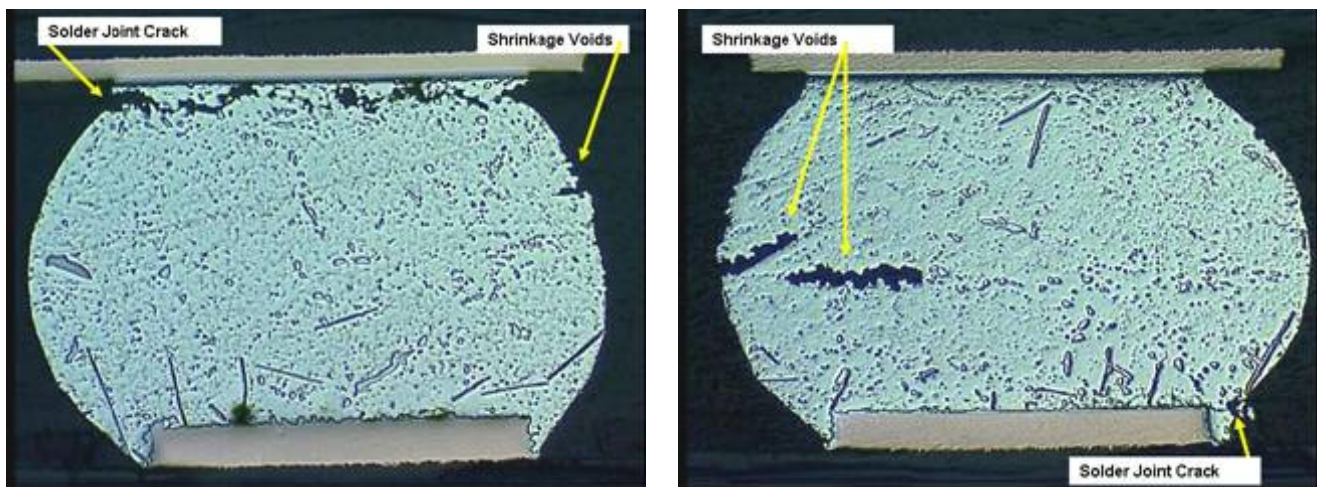
The BGA-225 solder joints were specifically examined for the presence of shrinkage voids. Shrinkage voids are phenomena observed in high tin containing Pbfree solder alloys and are the result of the formation of a tin dendritic matrix. The shrinkage voids are not associated with Kirkendall voiding phenomena, but instead are caused by the solidification behavior of the Pbfree solder alloy. Eutectic SnPb solder alloys do not experience shrinkage voiding. The purpose of the examination was to determine if any thermal cycle cracking and/or solder joint failures could be attributed to the presence of shrinkage voids. Figure 45 illustrates the shrink voids observed during the examination. Thermal cycle cracking or solder joint failures were not found to be associated with the shrinkage voids observed. Other industry investigations [18] have documented similar results for the shrinkage voids.

Figure 45 (left) SAC-SAC “Manufactured” solder joint Small shrinkage voids: (right) Large shrinkage voids

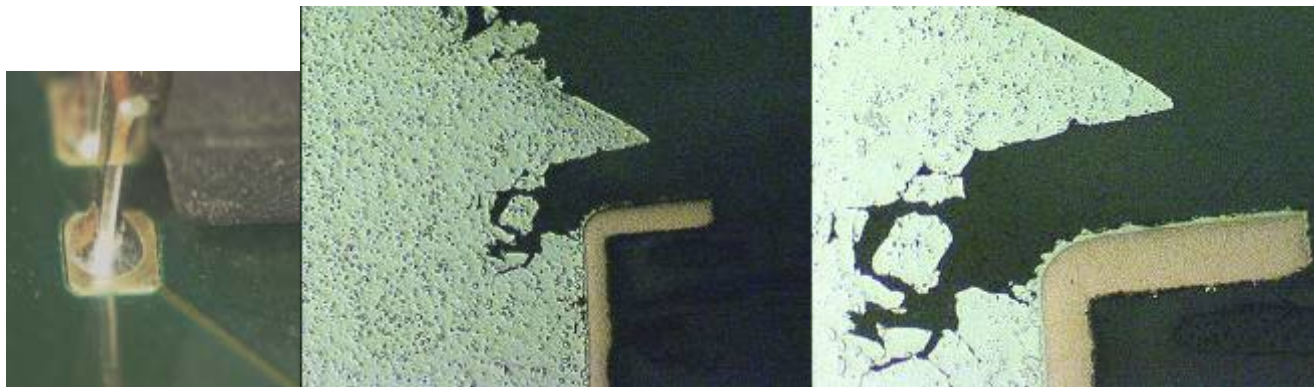
A second phenomena resulting from the solidification behavior of the Pbfree solder alloys is fillet lifting. Fillet lifting is primarily associated with plated thru hole technology and the wave soldering process. The DIP-20 components on the test vehicles that were processed using the SAC and SNIC solder alloys were examined for the presence of fillet lifting and shrinkage voids. Using Rockwell Collins standard solder joint inspection magnification values no instances of either fillet lifting or shrinkage voids were found. However, during the failure analysis of the DIP-20 component some occurrences of both phenomena were observed. Figure 46 illustrates a fillet lift found on a DIP-20 SAC-NiPdAu combination. Despite the fillet lift and visible cracking, this solder joint did not fail after 4743 total thermal cycles. Figure 47 illustrates a shrinkage void found during the failure analysis. These shrinkage voids did not contribute to the failure of the solder joint – after 4743 total thermal cycles the solder joint had not failed. Both the shrinkage void and fillet lifting observations of this investigation are in agreement with other industry reports [23].

Figure 46 DIP-20 SAC-NiPdAu combination illustrating a fillet lift (no solder joint failure after 4743 thermal cycles)

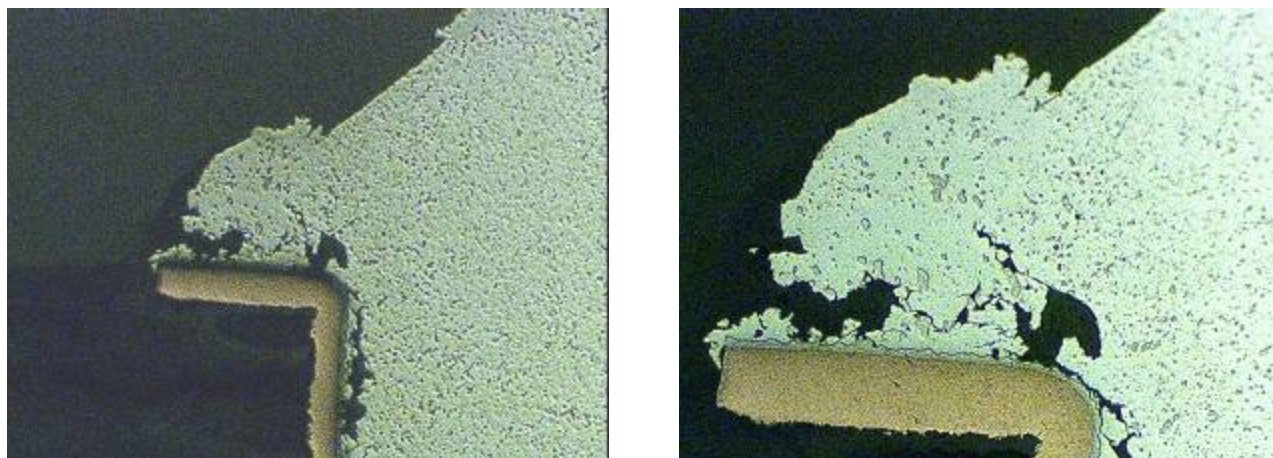
Figure 47 DIP-20 SAC-NiPdAu combination with a shrinkage void (no solder joint failure after 4743 thermal cycles)

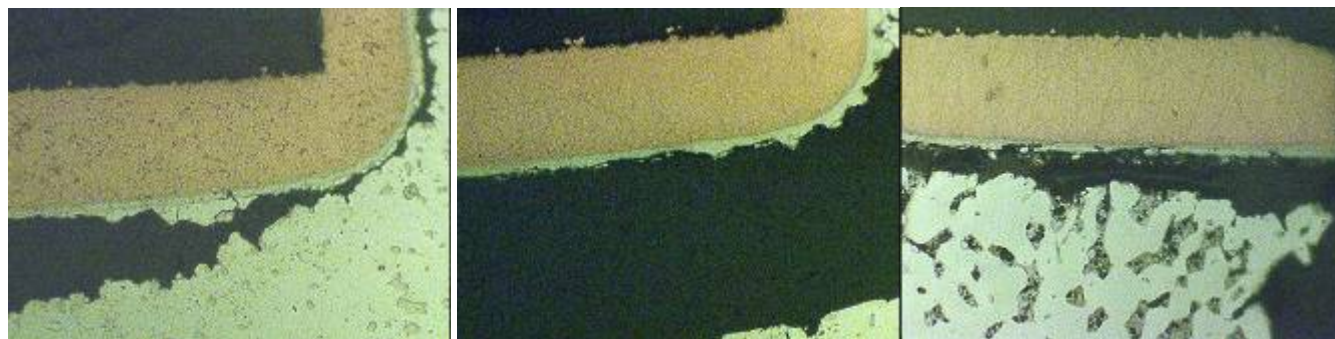
Figure 48 DIP-20 copper pads; (left) SAC alloy; (center) SNIC alloy; (right) SnPb alloy

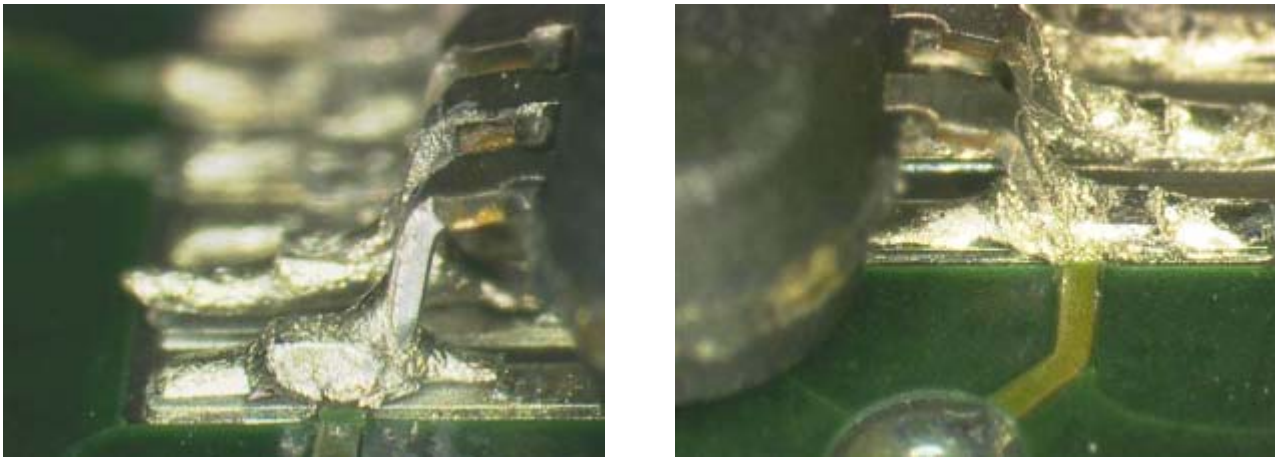
Figure 49 TQFP-208 SACB U3 (left) versus U57 (right) optical wettability comparison

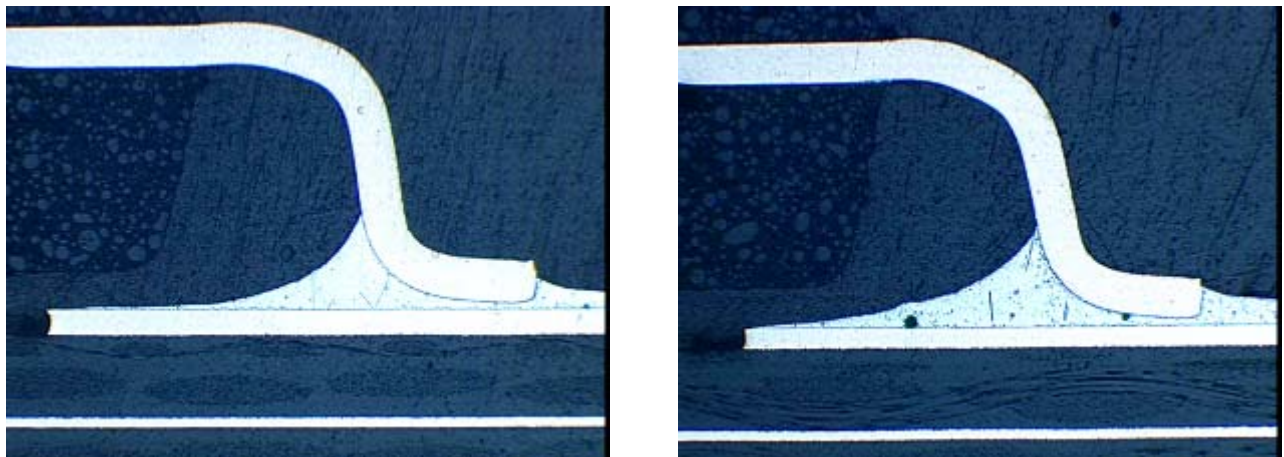
Figure 50 TQFP-208 SAC U3 (left) versus U57 (right) cross-sectional wettability comparison

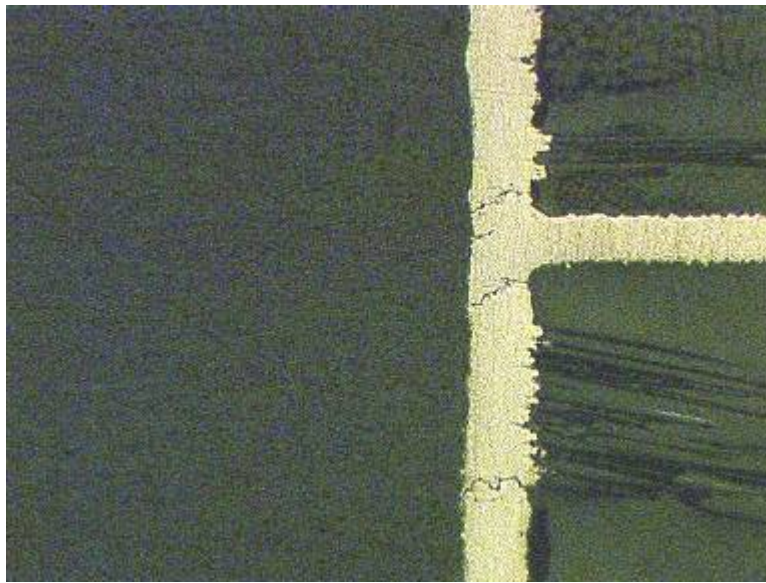
**Figure 51 Metallographic cross-sectional view of plated thru hole wall cracks
100X Magnification (Component U64, test vehicle 126)**
